# NATIONAL ACADEMY OF LEGAL STUDIES AND RESEARCH UNIVERSITY, SHAMEERPET, HYDERABAD

ITEM NO.17
REPORT ON CONDUCT OF ACCESS AUDIT AND RATIFICATION OF CONSULTANCY CHARGES AND OTHERS APPROVED BY THE VICE-CHANCELLOR & APPROVAL FOR IMPLEMENTATION OF THE RECOMMENDATIONS IN PHASED MANNER

Ar. Kavita Murugkar Design Bridge Foundation

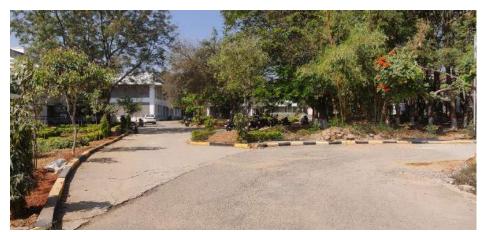
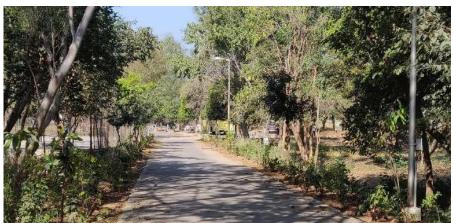
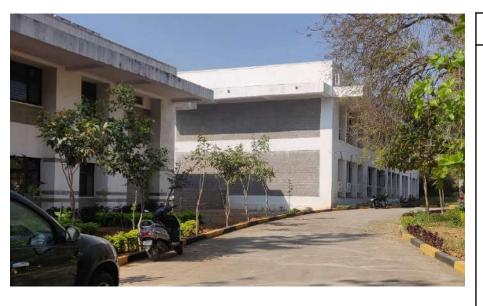
### 2. ABSENCE OF PATHWAYS AND DEMARKATED PARKING

- Pedestrian pathway not provided along some vehicular paths.
- There is no tactile guiding path including directional, hazard warning and positional tiles provided for independent navigation across all the external pathways / landscape surrounding the site.
- The pathway is not free of any barriers/obstacles like trees, potted plants, light poles, electrical junction box, vehicles, furniture etc
- There are no tactile warning blocks/ kerbs / guardrails around trees/ poles.
- Directional signage not provided at all junctions and as per standards.

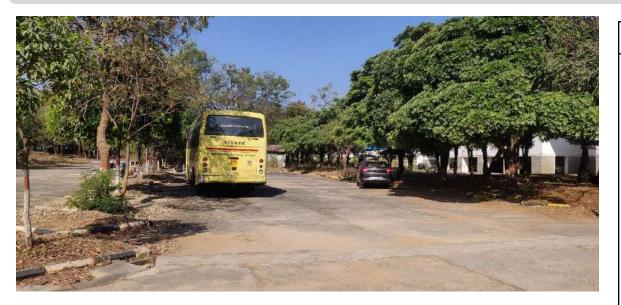
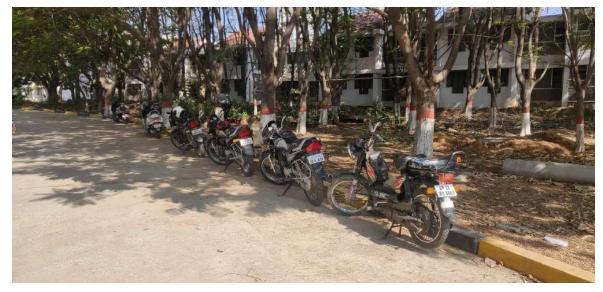
### 3. PARKING

- There is no demarcated parking lot available for visitors and staff, random parking observed on few internal roads.
- Accessible Parking bays not provided near any entrance in the building complex.

- Inadequate size of parking spaces.
- The parking area does not have firm and leveled surface.
- There is no demarcated drop off point for Persons with disabilities next to the parking.

- There is no covered shelter for the parking .Naturally shaded parking on ground is observed.
- There is no firm, covered, leveled, step free pathway and tactile guiding path minimally 1200mm wide connecting the parking bay with the building entrance.

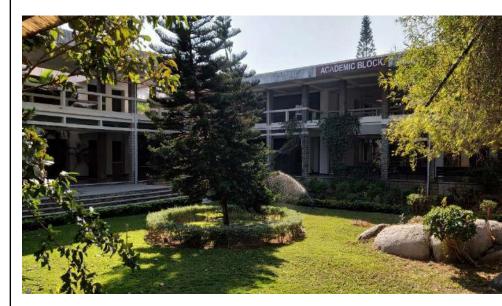
- Existing ramp access provided for wheelchair users is not as per NBC standards.
- Wayfinding and navigation through the quadrant is a challenge in absence of maps / signage.

- Hazardous parapet design considering persons with visual impairment.
- Audio tactile floor maps, floor directories not provided at strategic points for information.

- Handrails not provided near some stepped entries.
- Conspicuity edge strips not provided for distinction between riser and treads.
- Thresholds found at many door openings.

- Emergency evacuation measures such as evacuation maps, emergency exits not provided.

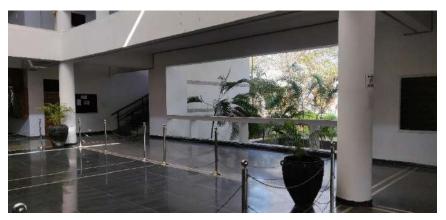
### 5. ADMIN - ACCESS INSIDE THE BLOCK

- Ad-hoc ramp provided to access admin block from basement, but no lift to reach upper floors.
- Ramp access provided from cafeteria, however slope provided is 1:10, thus steeper than required.
- Grooves in the floor finish of ramps make wheelchair manoeuvring difficult and hazardous.
- Signage to reach ramps not provided.
- Handrails not provided to ramp in admin block.

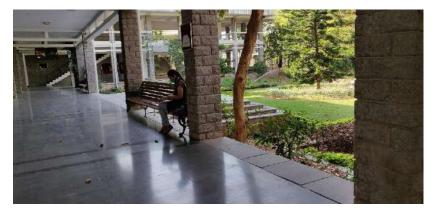
### 5. ACCESS INSIDE ADMIN BLOCK

- Accounts table should be at lower height to accommodate wheelchair user.
- Hazardous parapet design considering persons with visual impairment.
- Dustbin blocking the entry for toilet.
- No curb provided to open corridors at the courtyard side.

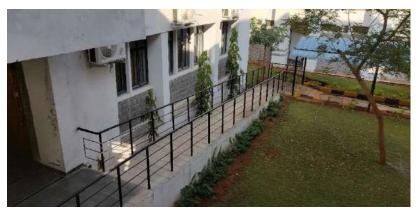
# 7. CLASSROOMS - RAMP ACCESS FROM HOSTEL SIDE

- Directional signage is absent.
- Existing ramp access provided for wheelchair users is not as per NBC standards.
- Grooves in the floor finish of ramps make wheelchair manoeuvring difficult and hazardous.
- Multilingual braille and tactile signage not provided at doors.

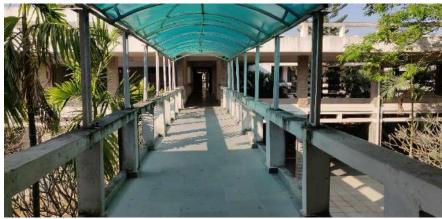
### 7. CLASSROOMS - ACCESS INSIDE CLASSROOMS BLOCK INCLUDING NEW

- Hazardous parapet design considering persons with visual impairment.
- Thresholds at door openings.
- Narrow door width to lift.
- Only steps to access new classroom block.
- Conspicuity edge strips not provided for distinction between riser and treads.
- Handrails not provided near steps.
- Drinking water fountain not as per standards.

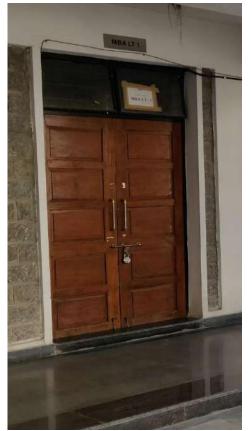
- Only steps to access new classroom block at both levels from academic / classroom block.
- Conspicuity edge strips not provided for distinction between riser and treads.
- Handrails not provided.
- Accessible toilet not provided.
- Threshold found at door openings.
- Directional signage is absent.
- Multilingual braille and tactile signage not provided at doors / service areas.

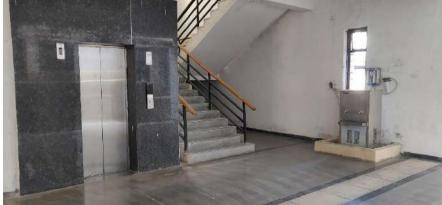
- Threshold found at door openings.
- Directional signage is absent.
- Multilingual braille and tactile signage not provided at doors / service areas.
- Handrails not provided under staircase to prevent hazard considering visual impairment.
- Tactile guiding path not provided in corridors.
- Conspicuity edge strips not provided for distinction between riser and treads.
- Drinking water fountains not as per standards.

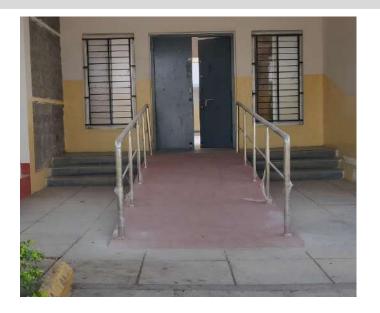
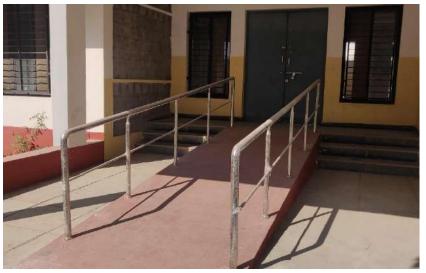
## 12. BOYS HOSTEL 3 & 4 – PROPOSED MODIFICATION TO ENTRANCE RAMPS

EXISTING SLOPE 1:10
REQUIRED SLOPE 1:12
RECOMMENDED FINISH – PLAIN BROOM FINISH CONCRETE

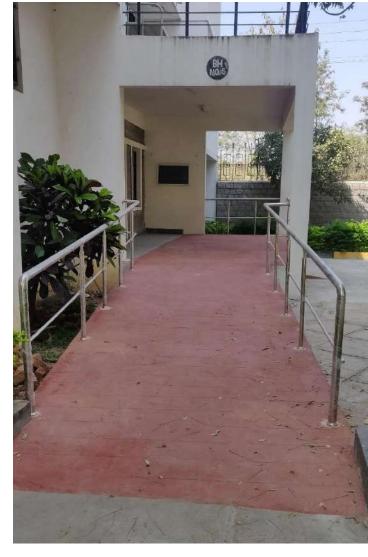
# 14. BOYS HOSTEL 5 - PROPOSED MODIFICATION TO ENTRANCE RAMP

EXISTING SLOPE 1:10 REQUIRED SLOPE 1:12

RECOMMENDED FINISH – PLAIN BROOM FINISH CONCRETE

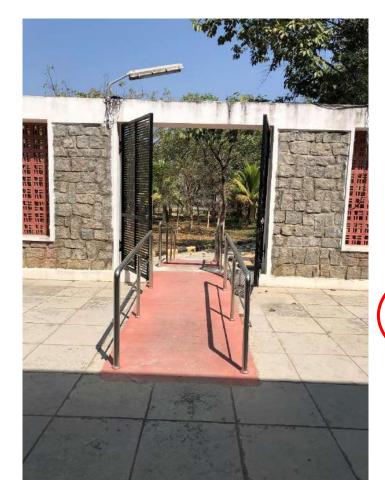
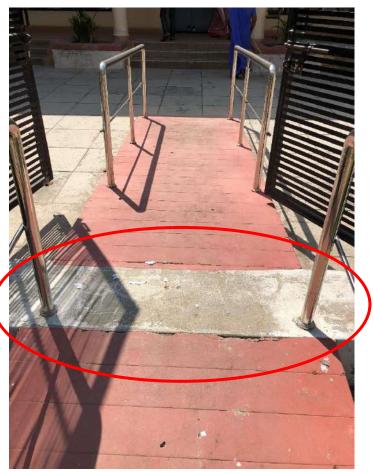
## 16. GIRLS HOSTEL BLOCK 1 – PROPOSED MODIFICATION TO ENTRANCE

ISSUE - STEEP RAMPS ON BOTH SIDES OF ENTRANCE, MAKING IT EXTREMELY HAZARDOUS AND INACCESSIBLE.
