# NATIONAL ACADEMY OF LEGAL STUDIES AND RESEARCH UNIVERSITY, SHAMEERPET, HYDERABAD

ITEM NO.17
REPORT ON CONDUCT OF ACCESS AUDIT AND RATIFICATION OF CONSULTANCY CHARGES AND OTHERS APPROVED BY THE VICE-CHANCELLOR & APPROVAL FOR IMPLEMENTATION OF THE RECOMMENDATIONS IN PHASED MANNER

Ar. Kavita Murugkar Design Bridge Foundation

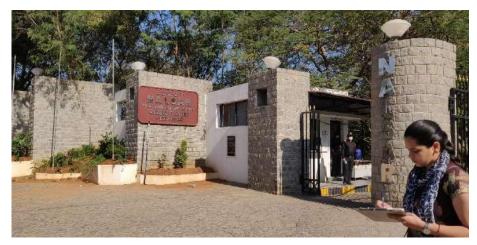
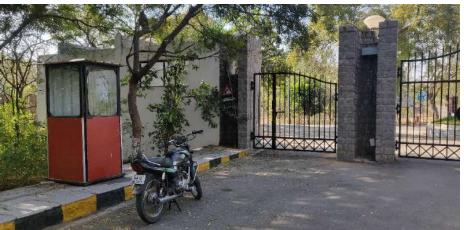
### 1. ENTRANCE GATE TO CAMPUS

CAMPUS SIGNAGE NOT LEGIBLE DUE TO POOR CONTRAST

WATCHMAN CABIN BLOCKING PATHWAY

- An accessible route does not connect the approach road to the walkway and entrance gate.
- The name/signage of the building at the entrance gate is not legible due to poor colour contrast.
- There is no footpath on either side of the entrance gate.
- It does not have a tactile guiding path including directional, hazard warning and positional tiles directing till the entrance gate.
- There is no beeper or audio signal at the entrance gate to guide PwVI.
- There are no directional signs indicating location of accessible facilities at the entrance gate.
- There is no multi lingual, tactile pictographic site map of the campus at the entrance gate.

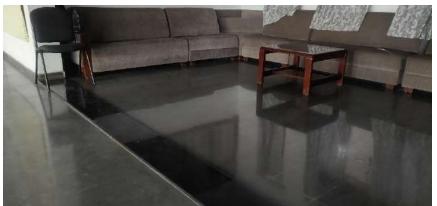
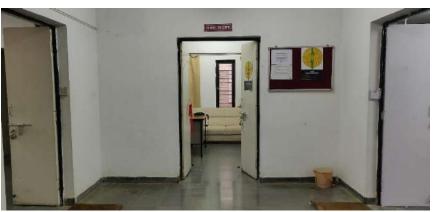
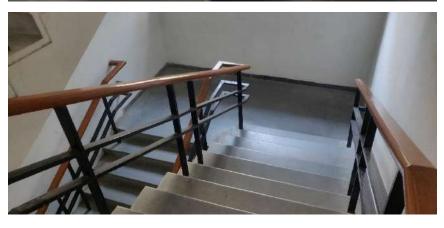
- Tactile guiding path not provided in circulation areas.
- Thresholds at door openings.
- Level difference in waiting area.
- Counselling room is provided in basement.
- Handrails not provided at the staircase landing level.
- Conspicuity edge strips not provided for distinction between riser and treads.

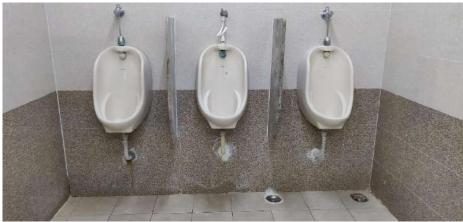
- Accessible lift not provided.
- No grab bars in existing toilets.
- Handrails not provided for auditorium stage as per NBC standards.
- Accessible toilet not provided.

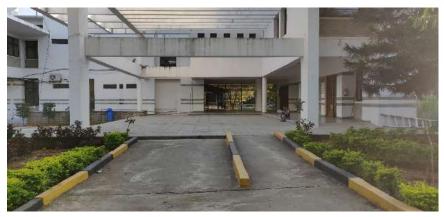
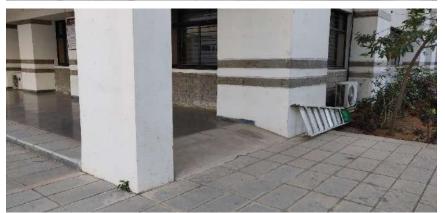
# 7. CLASSROOMS - RAMP ACCESS FROM HOSTEL SIDE

- Existing ramp access provided for wheelchair users is not as per NBC standards.
- Handrails not provided near the ramps.
- Directional signage is absent.
- Tactile guiding path not provided.

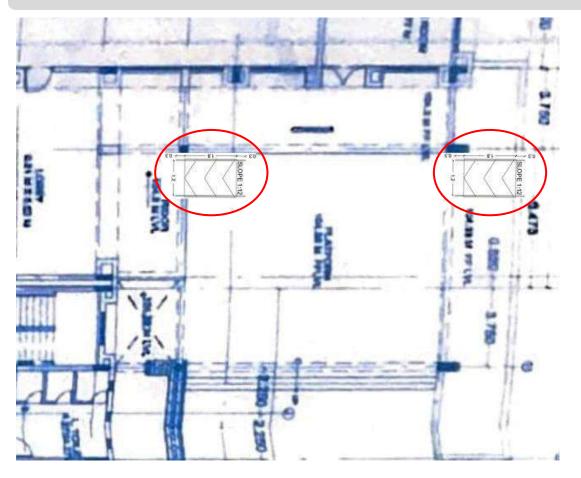
# 7. CLASSROOMS - PROPOSED RAMP ACCESS TO QUADRANT BLOCK AND CLASSROOMS FROM HOSTEL SIDE

AT THE ENTRANCE FROM HOSTEL BLOCK

ADHOC RAMP TO BE REMOVED

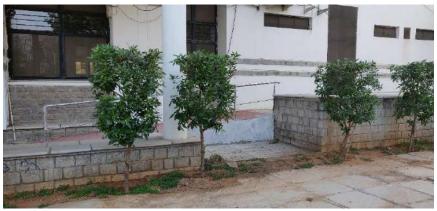
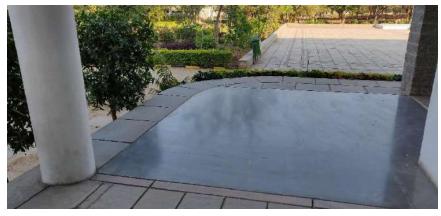
# 8. LIBRARY & COMPUTER BLOCK - RAMP ACCESS FROM HOSTEL AND QUADRANT SIDE

- Directional signage is absent.
- Existing ramp access provided for wheelchair users is not as per NBC standards.
- Handrails not provided.
- No curb provided at the open side of corridor for safety.

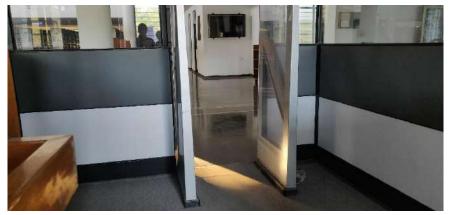
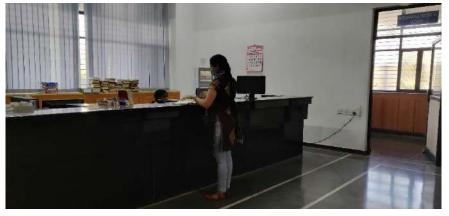
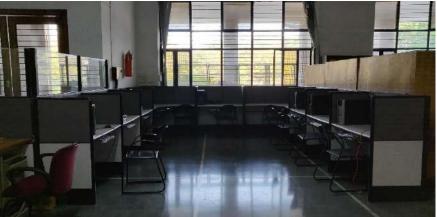
### 8. LIBRARY - ACCESS INSIDE

- Multilingual braille and tactile signage not provided at doors / service areas.
- Narrow entry to the library.
- Conspicuity edge strips not provided for distinction between riser and treads.
- Reception desk not per NBC standards to accommodate wheelchair users.
- Existing accessible toilet not as per NBC standards.
- The computers do not have reading software's.
- Accessible lift not provided.

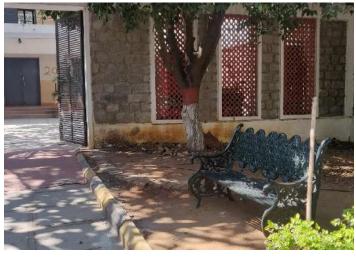
**RESTING BENCHES NOT ACCESSIBLE**

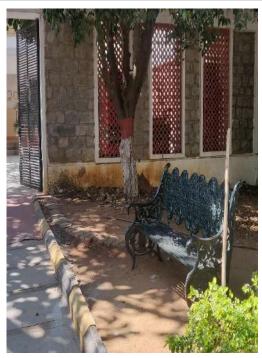
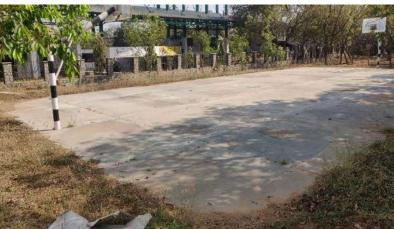
#### 9. BOYS HOSTEL COMPLEX - PATHWAYS INSIDE

- Narrow pedestrian entry to the hostel block.
- External pathways are undulating, with steep slopes and without railing.
- Resting bench is not accessible.
- No firm pathway leading to basketball court.
- Directional signage is absent in the external and internal areas.
- Grooves in the floor finish of ramps make wheelchair manoeuvring difficult and hazardous.
- Tactile guiding path not provided in circulation areas.

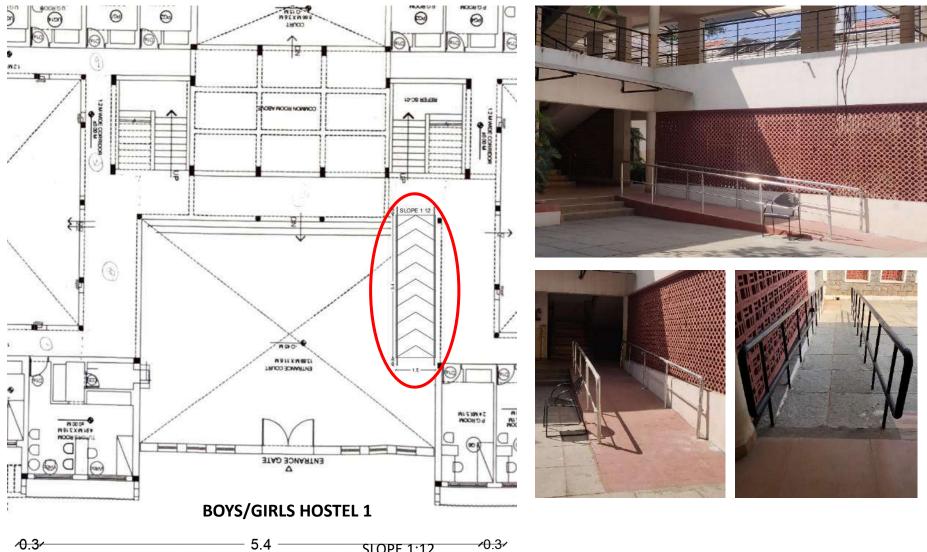
## 10. BOYS HOSTEL BLOCK 1 – PROPOSED MODIFICATION TO ENTRANCE RAMP

EXISTING SLOPE 1:10 REQUIRED SLOPE 1:12

RECOMMENDED FINISH – PLAIN BROOM FINISH CONCRETE

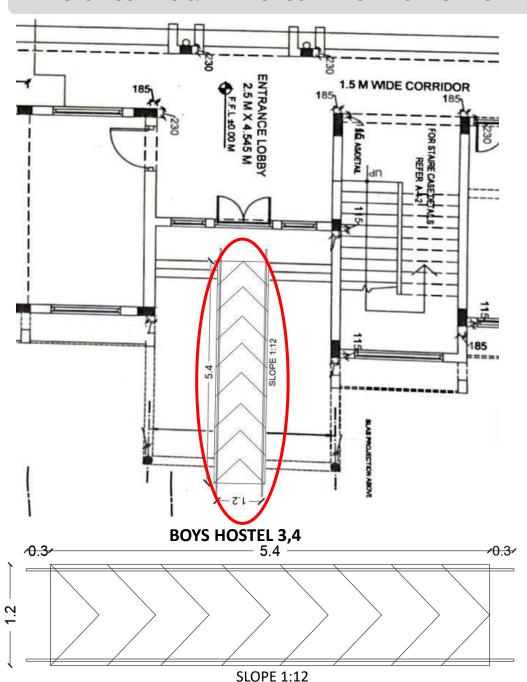
## 12. BOYS HOSTEL 3 & 4 – PROPOSED MODIFICATION TO ENTRANCE RAMPS

EXISTING SLOPE 1:10
REQUIRED SLOPE 1:12
RECOMMENDED FINISH – PLAIN BROOM FINISH CONCRETE

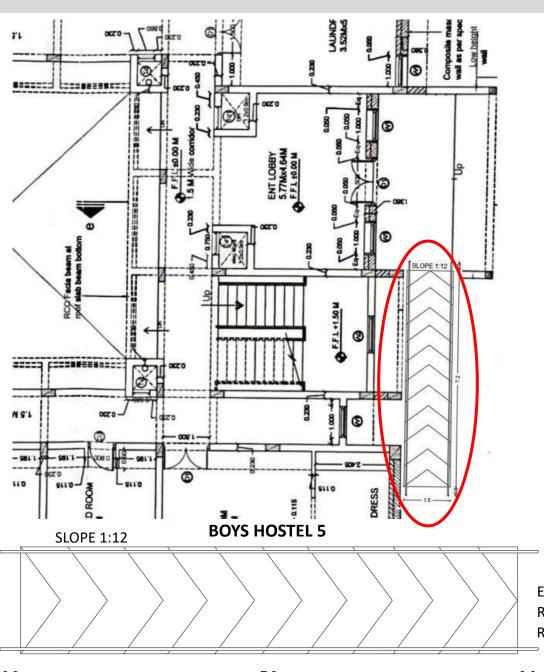
# 14. BOYS HOSTEL 5 - PROPOSED MODIFICATION TO ENTRANCE RAMP

EXISTING SLOPE 1:10 REQUIRED SLOPE 1:12

RECOMMENDED FINISH – PLAIN BROOM FINISH CONCRETE

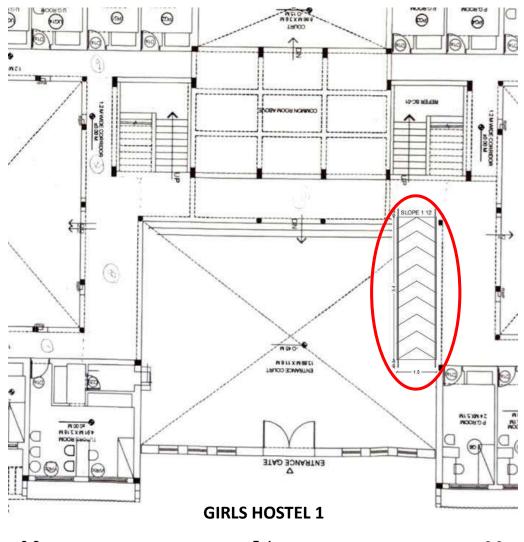
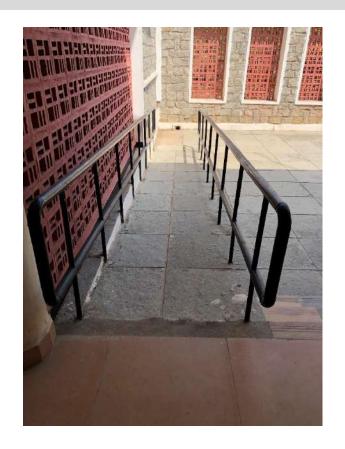
## 16. GIRLS HOSTEL BLOCK 1 – PROPOSED MODIFICATION TO ENTRANCE RAMP

EXISTING SLOPE 1:10 REQUIRED SLOPE 1:12

RECOMMENDED FINISH – PLAIN BROOM FINISH CONCRETE

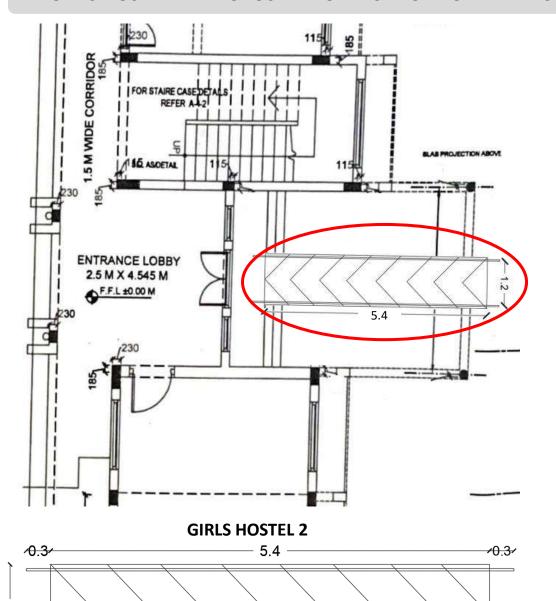
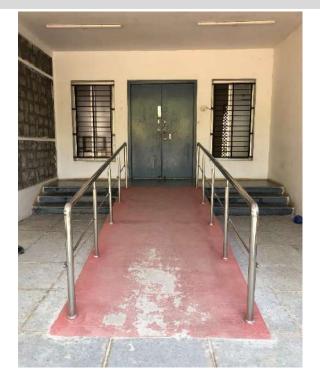
## 17. GIRLS HOSTEL 2 – PROPOSED MODIFICATION TO ENTRANCE RAMP

**EXISTING SLOPE 1:10** REQUIRED SLOPE 1:12

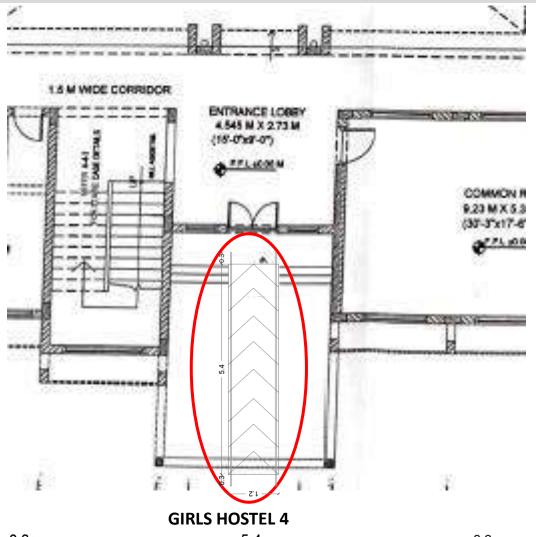
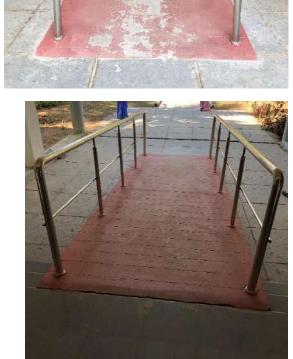
## 19. GIRLS HOSTEL 4 – PROPOSED MODIFICATION TO ENTRANCE RAMP

EXISTING SLOPE 1:10
REQUIRED SLOPE 1:12

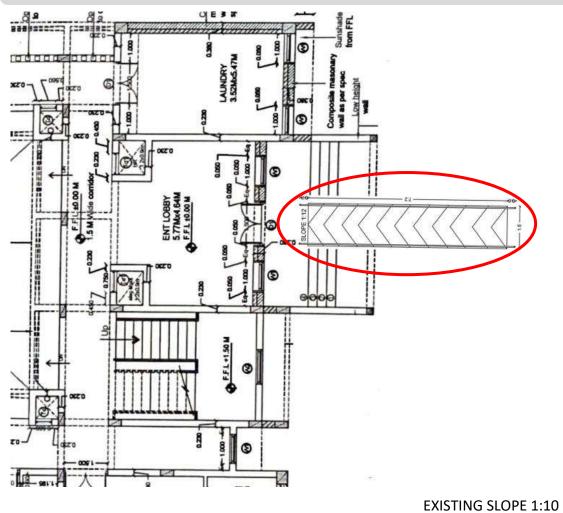
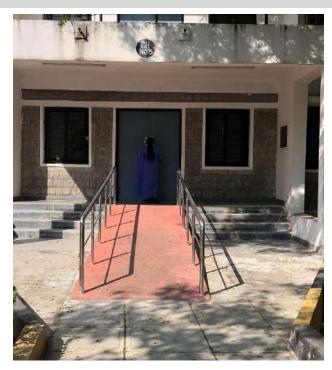
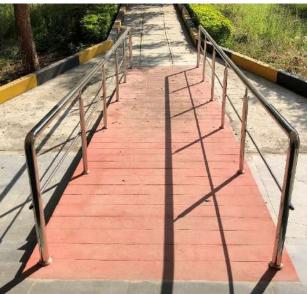
## 20. GIRLS HOSTEL 5 - PROPOSED MODIFICATION TO ENTRANCE RAMP

SLOPE 1:12 GIRLS HOSTEL 5 REQUIRED SLOPE 1:12

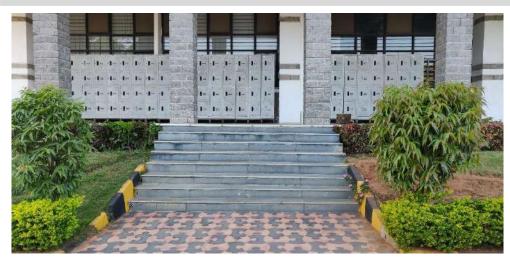
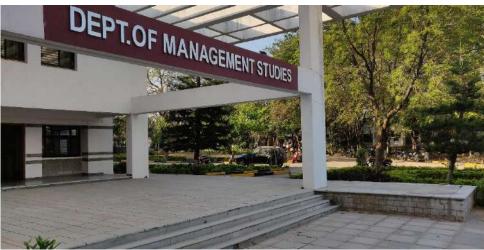
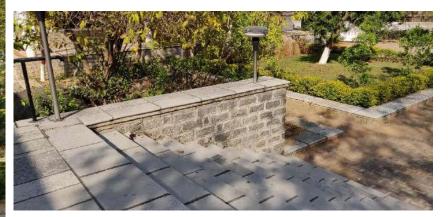
#### 3. STEPS AND STAIRCASES

- Steps / stairs lack contrast in risers and treads, making their identification difficult for PwVI.
- No tactile guiding path provided for navigating till the steps / stairs for PwVI.
- No warning tiles in floor at beginning and end of steps/ stairs.
- Handrails mostly not provided or only on one side at 900 mm.
- Insufficient and inaccessible directional and general signage.
- · Handrails in some places are not circular and easy to grip

- Cordon off the underside of staircases, where the headroom is 2000mm or less from the finished floor level, with a guard rail or design in such a way to stop people from walking underneath that part of the staircase. Generally, people with a guide stick can detect an area of obstruction up to 685mm high from the ground level.

- Accessible directional, multilingual and tactile signage to be provided as per standards.
- Floor wise key plans are proposed next to steps .

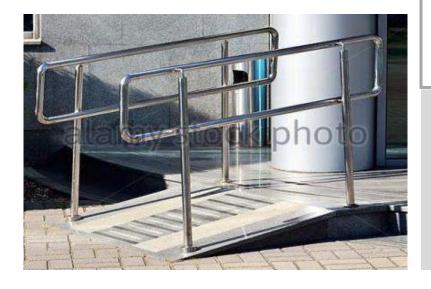
#### 4. HANDRAILS

- Handrails are not provided on both sides of stairs everywhere
- Handrails along some staircases do not have a circular section
- Handrails not extending beyond the steps
- Colour of handrails not in contrast with surrounding wall
